Mastering the Challenge of Adjacent Class II Defects: A Case Study with the Quad Matrix System

Case History:

A 62-year-old male presented to our dental office with complaints of gum pain in the maxillary right quadrant and an inability to chew effectively.

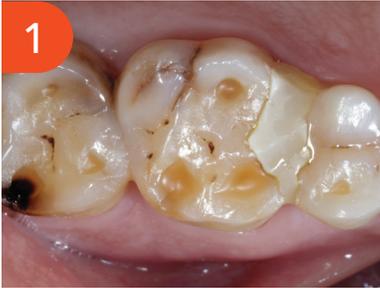
Clinical examination reveals composite restoration was done in between the first molar and second premolar. It looks like the restoration was just placed without any sectional matrix system joining the adjacent Class II defect. The palatal view shows the composite was placed directly on the gums, leading to gingival inflammation and pain. Overall, the patient's teeth show signs of erosion with loss of a good amount of enamel, suggestive of acid reflux.

Composite restoration placed in adjacent defects without use of any sectional matrix system. Occlusal erosion facets seen due to acid reflux with flat anatomy of the teeth.

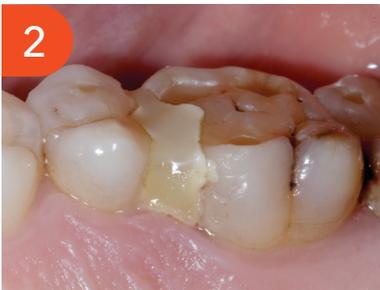
Composite restoration impinging on gingival tissue, leading to pain for the patient.

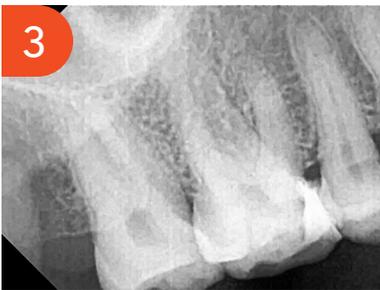
X-ray reveals adjacent Class II defects on tooth #15 and #16 with no close proximity to the nerve. The single composite restoration was placed in between these two defects.

IOPA radiograph revealing a restoration with improper contouring and noticeable overhangs.

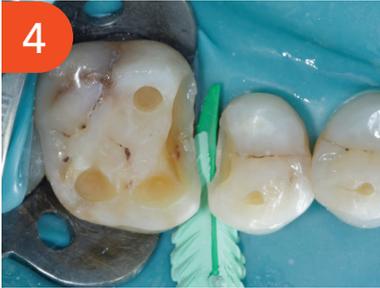
Caries end point removal, achieving peripheral seal zone, and removing unsupported enamel. The picture was taken after air abrasion and selective etching was performed. Garrison® Strata-G™ wedge was placed as prewedging to protect rubber dam.

Caries removal: Utilize caries dye for the thorough removal of carious tissue in teeth #15 and #16. The old composite is removed and infected caries is removed using slow speed round carbide bur. It is essential to establish a peripheral seal zone free from infected and affected dentin to ensure the best bonding strength.

Enamel preparation: Remove all unsupported enamel using a super fine diamond bur (yellow band). For new cavity designs, employ Cala Lilly burs, which are specifically engineered for adhesive composite restorations and designed to resist tooth fracturing.

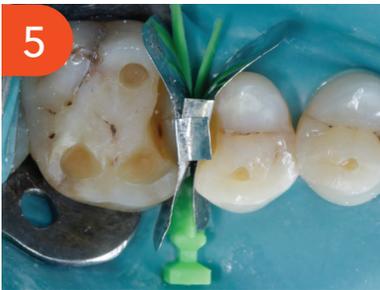
The 3D Fusion™ Firm band FXH200 was securely positioned using a large Quad wedge, placed from buccal, ensuring a tight seal.

The Firm band (FXH200) was placed in the distal defect of tooth #15 and secured using a large Quad wedge (image 5).

Next, an identical band was inserted into the mesial defect of tooth #16 by slightly repositioning the wedge, allowing the band to pass beneath it. The wedge was then reinserted to its full length, holding the bands in place with gentle finger pressure, ensuring both bands were securely positioned beneath the wedge (image 5).

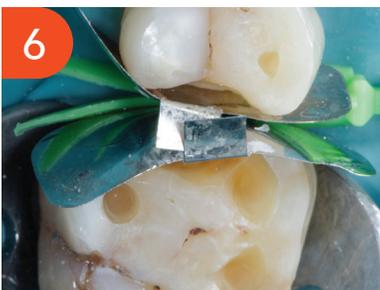
Premolar is ready for the injection molding using Shofu Injectable Xsl A3O and Packable Shofu Beautiful LS II A3.5.

After applying the bonding agent, we used a thin layer of Shofu Injectable Xsl—a high-strength, self-leveling, second generation injectable material—to seal the dentin. This initial layer, approximately 0.5 mm thick, is crucial for protecting the hybrid layer from shrinkage stress. The self-leveling properties of this material allow it to effectively adapt to uneven surfaces, ensuring a smooth application without air bubbles and minimizing post-operative sensitivity.

For the second increment, we placed a small quantity of Injectable Xsl A3O followed by packable composite Shofu Beautiful LS II A3.5 in injection molding technique manner. The excess composite is removed and marginal ridge is contoured properly.

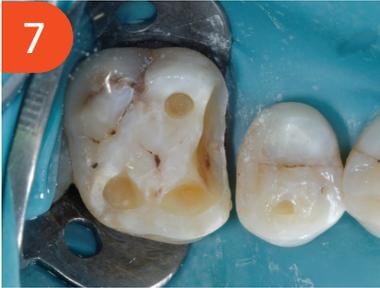
After removal of the bands, note the contour without any excess flange.

After curing from all sides, the band and wedge are removed. Due to the rigidity of the band no excess flange and over contoured seen due to placing adjacent band (image 7).

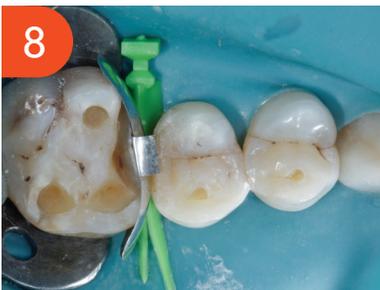
The Quad large wedge was placed and secured with the FXH200 band from the palatal side, addressing the wider defect on that side and effectively eliminating any gaps at the gingival seat area.

Due to the larger defect on the palatal side compared to the buccal, we inserted the Quad large wedge from the palatal. The unique design of the wedge, with its broader area, ensures that the band is securely positioned at the wider defect, eliminating any gaps at the gingival seat area (image 8).

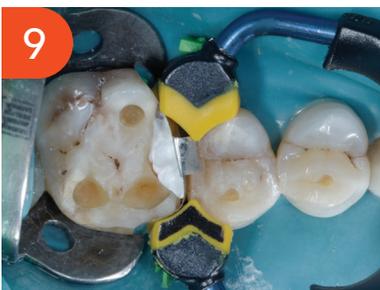
The Quad ring was placed with its driver tip from the buccal side, and Teflon tape was used to shape the band to match the contour of the adjacent tooth, ensuring an ideal contact and contour.

Once the band is securely in place, the Quad ring is selected and positioned with its driver tip on the buccal side, following the placement of the wedge from the palatal. Teflon tape is then placed inside the defect to shape the band to the adjacent tooth, ensuring ideal contour and contact (image 9).

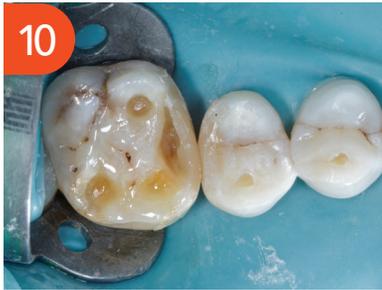
Converting Class II to Class I.

The bonding process and a thin layer of Shofu Injectable Xsl were applied in the same manner as for tooth #15. Due to the larger defect, we decided to convert the Class II into a Class I by first creating the wall. To achieve this, we used the snow plow technique with a stress-reducing layering approach. This involved building the walls separately on the palatal and buccal sides using Shofu Injectable XSL A30 and Packable Shofu Beautifil LS II A3.5 (image 10).

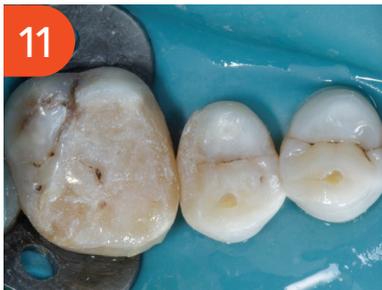
After restoring tooth #16, note the ideal contacts and contours, with no excess flange present.

The contours and embrasures were well established and finished using a Shofu Super Snap purple disk. The oxygen inhibition layer was removed using sodium bicarbonate powder with an air polisher unit (image 11).

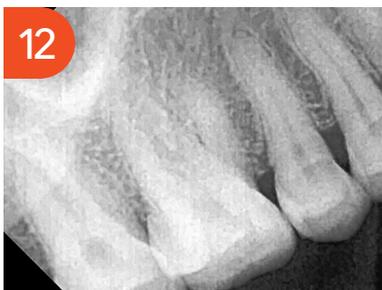
IOPA radiograph demonstrating well-established natural contacts and contours, free from overhangs. Note the properly formed occlusal embrasures.

An IOPA was taken to ensure there are no overhangs (image 12).

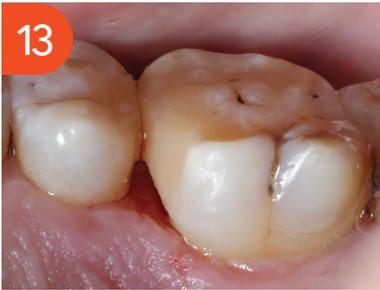
Note the soft tissue defect produced by previously faulty restoration. The finished restoration shows no overhangs which allows tissue healing in a natural manner.

A large soft tissue defect is visible due to the faulty restoration. The newly restored teeth will support healing and promote soft tissue growth (image 13).

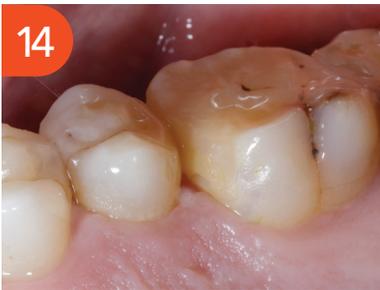
Papilla growth post 15 days.

The patient was recalled after two weeks for a soft tissue assessment, where it was noted that the interdental papilla had grown back naturally (image 14).

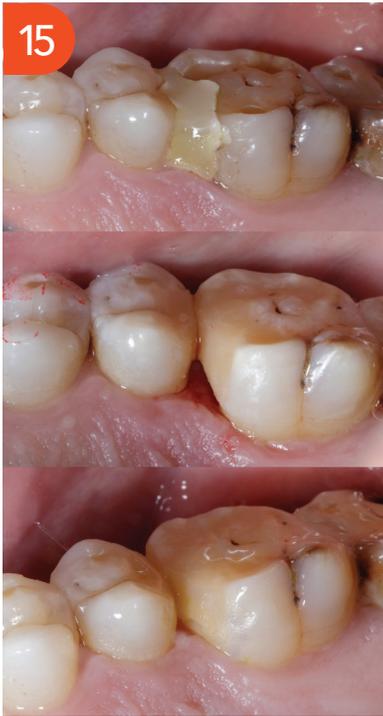
A photo collage illustrating the progression from the initial damage to the restoration, followed by the formation of the interdigital papilla.

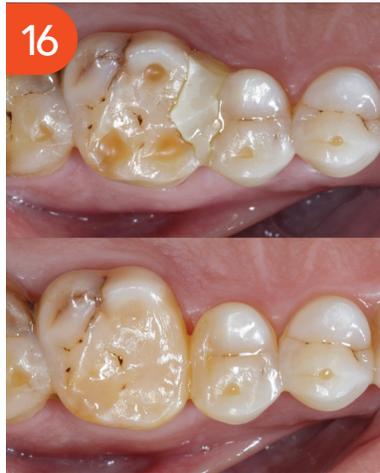
Before and After Collage:
The images illustrate the natural contacts, contours, and morphology of the restoration.

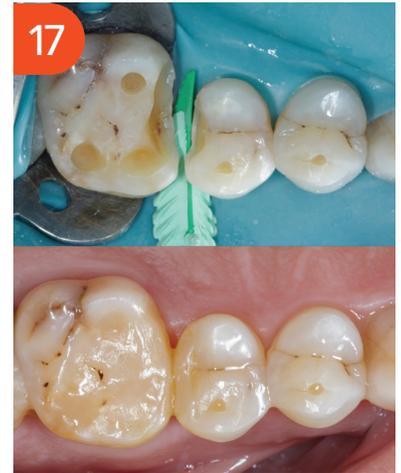
Before and After Collage:
The images illustrate the natural contacts, contours, and morphology of the restoration.
